# Manhole Inspection Summary

Manhole # S07YY1027MH

**Inspection** ☐ Is Incomplete Rating: **3) Fair**

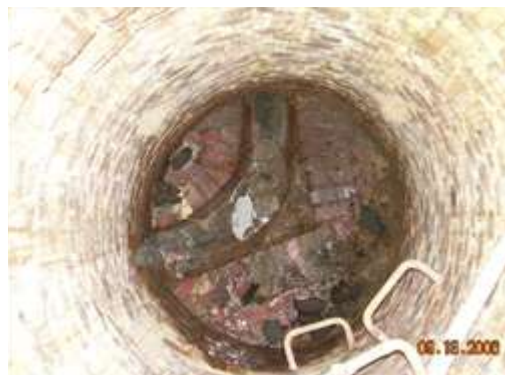
Top View

Adjustment infiltration. Bench and Channel debris.

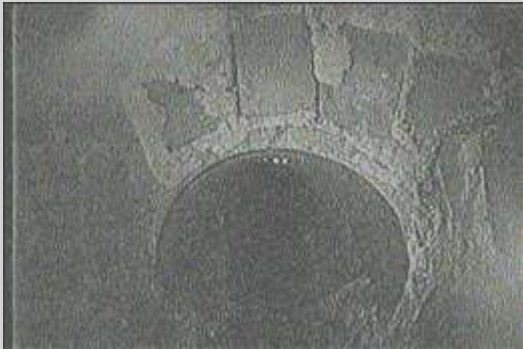
### 8 in. Circular Gravity Sewer Pipe Out @ 12 O'Clock

Infiltration: **None** Pipe Seal Cond: **Cracked**

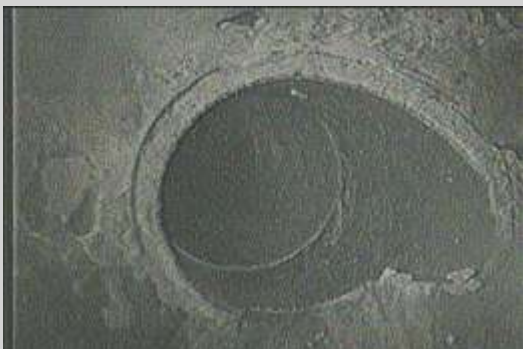
### 6 in. Circular Gravity Sewer Pipe In @ 7 O'Clock

Infiltration: **None** Pipe Seal Cond: **Broken**

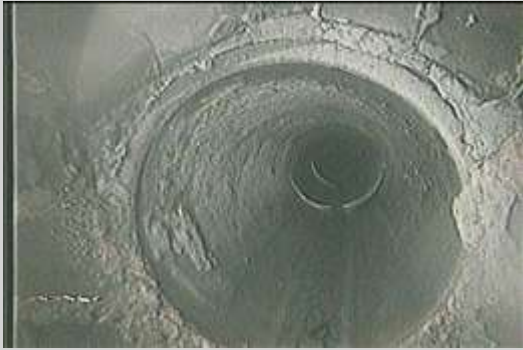
Pipe In @ 9 O'Clock

Infiltration: **Evidence**

Pipe Seal Cond: **Cracked**
